Union of Concerned Scientists Citizens and Scientists for Environmental Solutions issue brief

HEADACHES AT PALISADES: BROKEN SEALS & FAILED HEALS

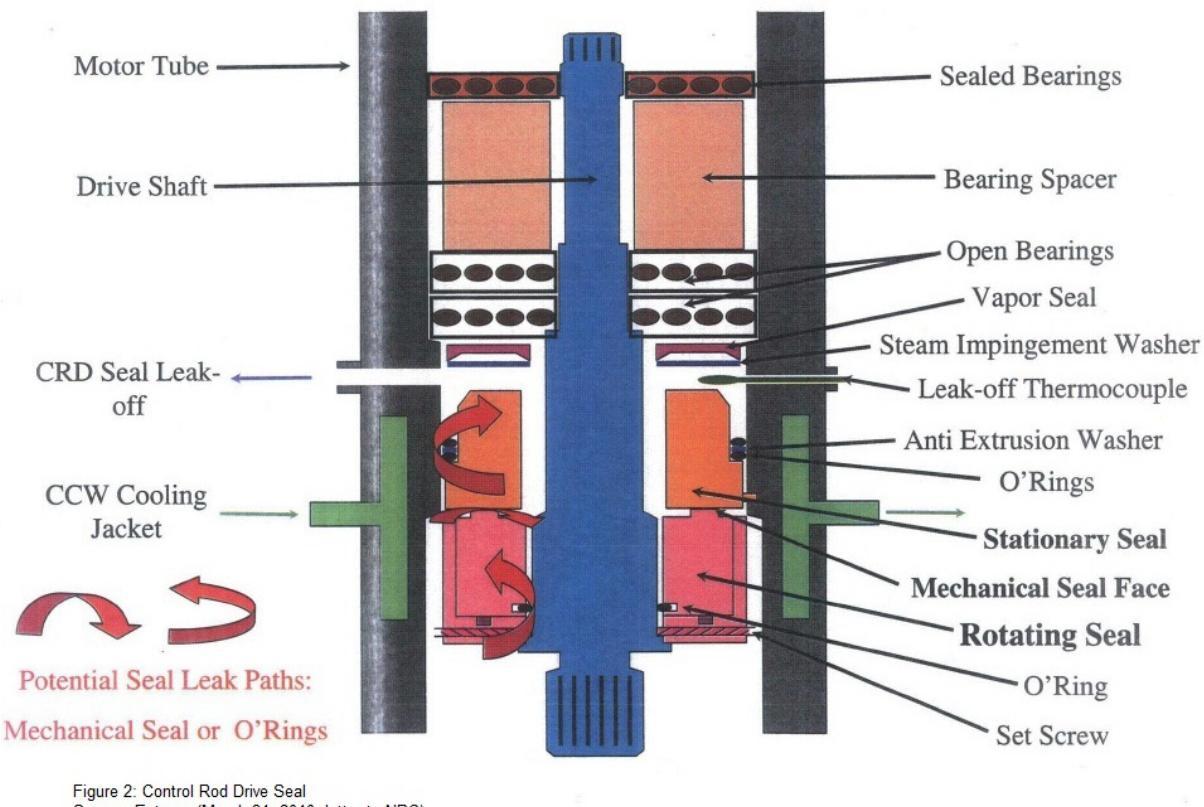
Figure 2 illustrates the seal design used at Palisades. The vertical blue piece in the center represents the metal shaft connecting an electric motor to a control rod. This shaft rotates when the electric motor operates to re-position the control rod, but this portion of the shaft does not move up or down. The bottom of this shaft is connected to another vertical metal shaft via beveled gears. As the blue shaft rotates, the gearing causes the parallel shaft to raise or lower to re-position the control rod. The red pieces toward the bottom are a cutaway view of what is a doughnut-shaped rotating seal that fits between the shaft and the outer metal tube (sometimes called the nozzle). Above this seal is a stationary seal, also doughnut-shaped and shown in orange. Below the seals, the nozzle is filled with

water at reactor pressure. The cushiony nature of the seals allows them to better fill the space between the shaft and the tube. However, the seal hardens and becomes less effective when heated above 250°F. Because the water is at a higher temperature (over 500°F), the region near the seals is supplied with cooling water from the component cooling water (CCW) system, shown in green in the figure. The seals prevent, or at least limit, water from leaking out of the reactor vessel. If water leaks past the seals, it is detected by a "leak-off" thermocouple (or thermometer) shown on the right side. The leaking water is routed to the containment sump via the control rod drive (CRD) seal leak-off line shown on the left side.

In 2008, the company conducted an evaluation to identify the causes of recurring control rod seal leakage. The primary cause was attributed to inadequate seal area cooling. A secondary cause was poor quality of the rotating seals (the red item in the graphic on page 2) and fabrication-related material defects of the stationary seals (the orange item in the graphic on page 2).

During the refueling outage in 2006, workers modified the ventilation to the upper head to increase cooling in the area occupied by the control rod drive mechanisms. By lowering the seal operating temperatures, the seals would not harden.

During the refueling outage in 2009, workers replaced the seals on all 45 control rods. In addition, workers again modified the ventilation system to provide more cooling air flow to the region of the control rod drive mechanisms above the reactor vessel head.
