Union of Concerned Scientists Citizens and Scientists for Environmental Solutions issue brief

HEADACHES AT PALISADES: BROKEN SEALS & FAILED HEALS

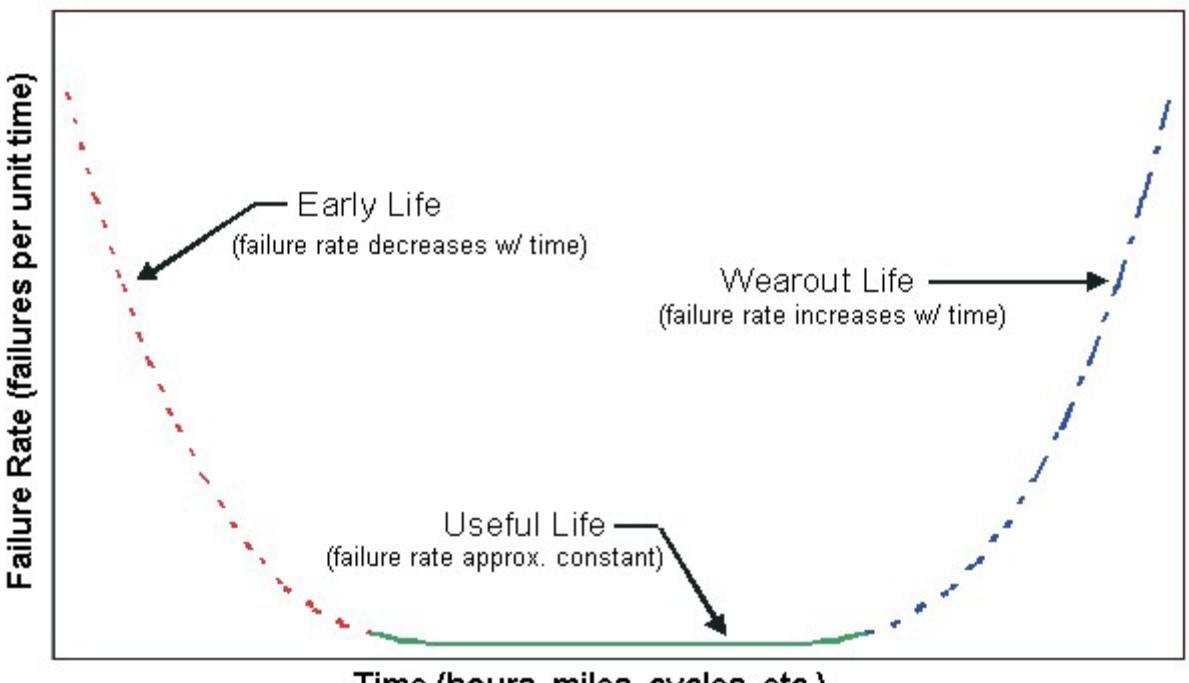
The control rod seal problems during Palisades' operating lifetime can be explained by the bathtub curve. There's an annoying Catch-22 associated with the bathtub curve for consumable items like the control rod seals. When a seal wears out and leaks (i.e., is on the right side of the curve), its replacement starts out on the left side of the curve, and will also have a relatively high failure rate.

Figure 3: Bathtub Curve.
